ST ANTHONY & OUR LADY OF MERCY RC CHURCH, HULL

REPORT ON VISIBLE DAMAGE TO CHURCH DUE TO WATER INGRESS

St Anthony's and Our Lady of Mercy Roof Information

Date: 04, July, 2024

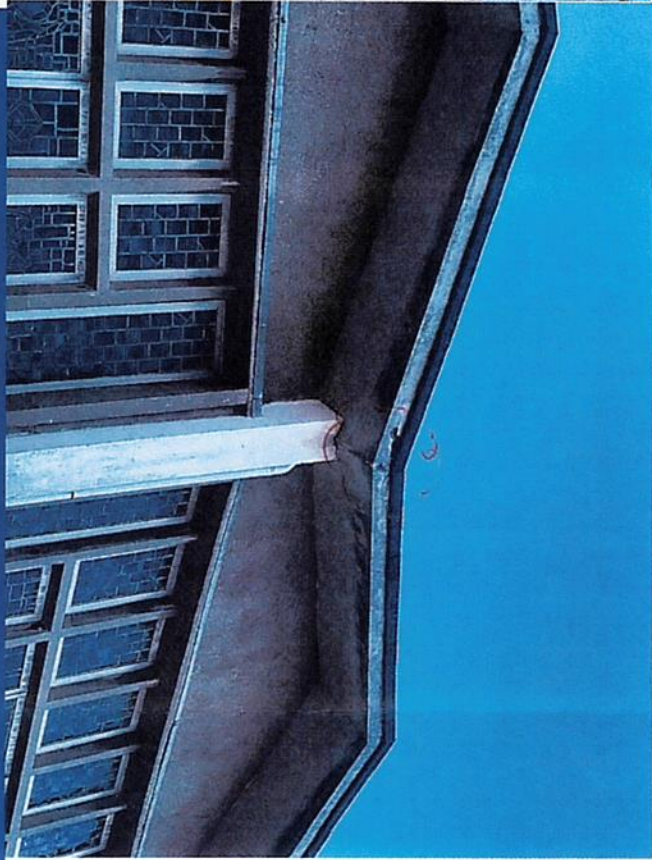
The underside of the roof overhang around the perimeter of the fan shape has no protective covering and showing signs of failure. There are several large holes at the lower-level joints. The loose concrete requires removal, the steelwork treating, temporary shuttering and high build mortar repairs are required to be followed by a protective coating.

Typical perimeter
antennas

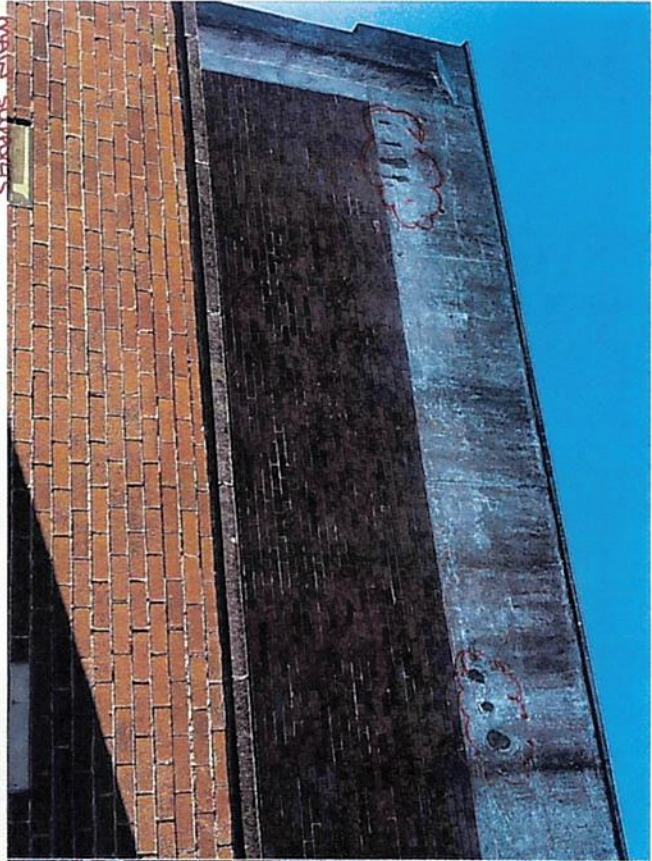
The main support wall has areas of exposed steelwork and evidence of earlier repairs. The loose concrete needs removing, the steel bars treating, repair mortar applied, and a preservative coating applied.

Main structure

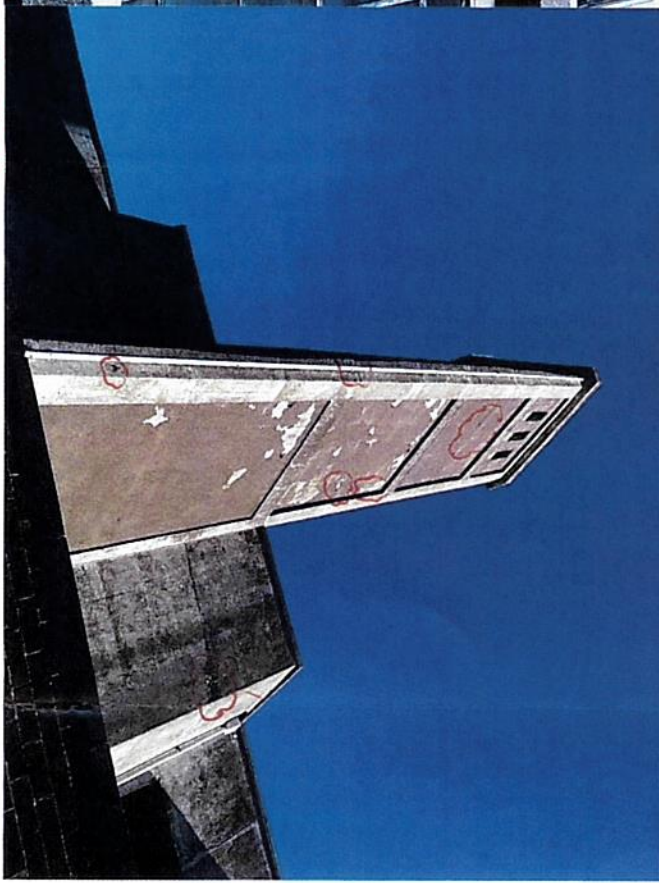
The Bell tower which also acts as a lateral restraint to the main support wall also has exposed reinforcing bars. The loose concrete needs to be removed, the steel bars treated, repair mortar applied, and a preservative coating applied to prevent further corrosion.

Ball tower

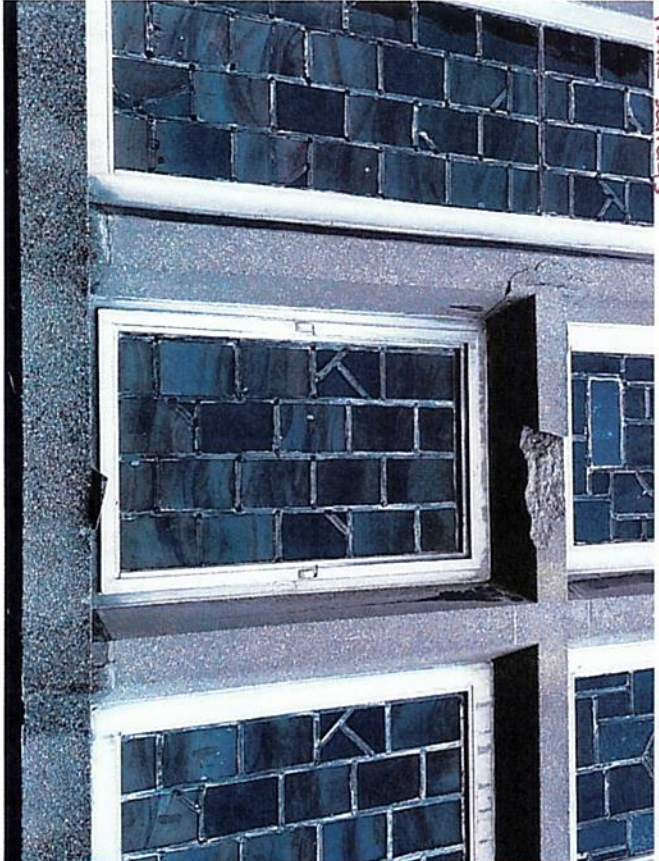
The concrete framed windows are spalling and require high build mortar repair.

Windows

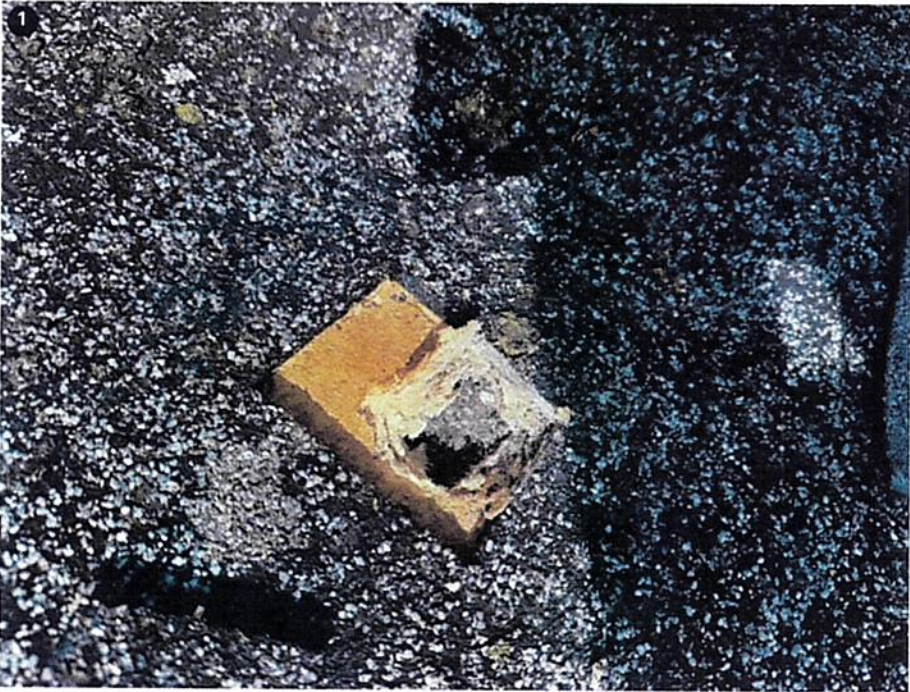
Core sample taken revealed fibreboard insulation 25mm R1

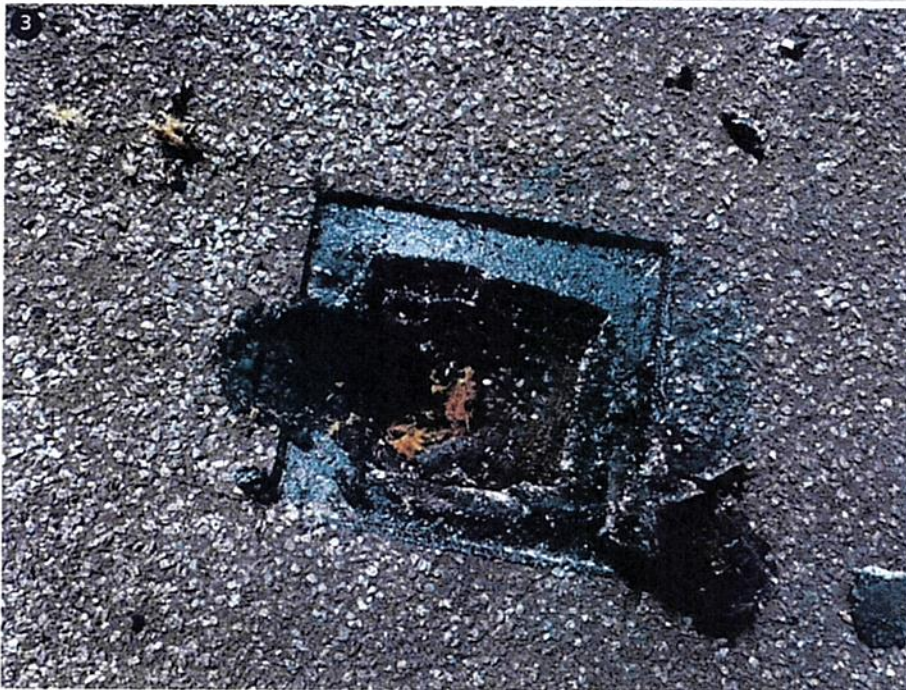
Core sample to R2 showed saturated insulation over concrete deck

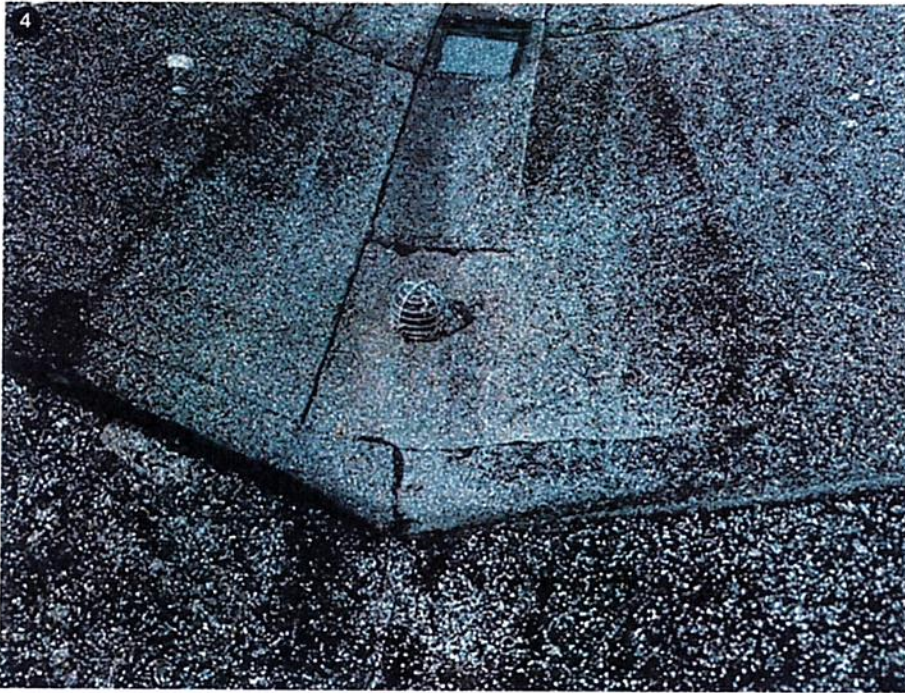
Core to gutter area showed no insulation

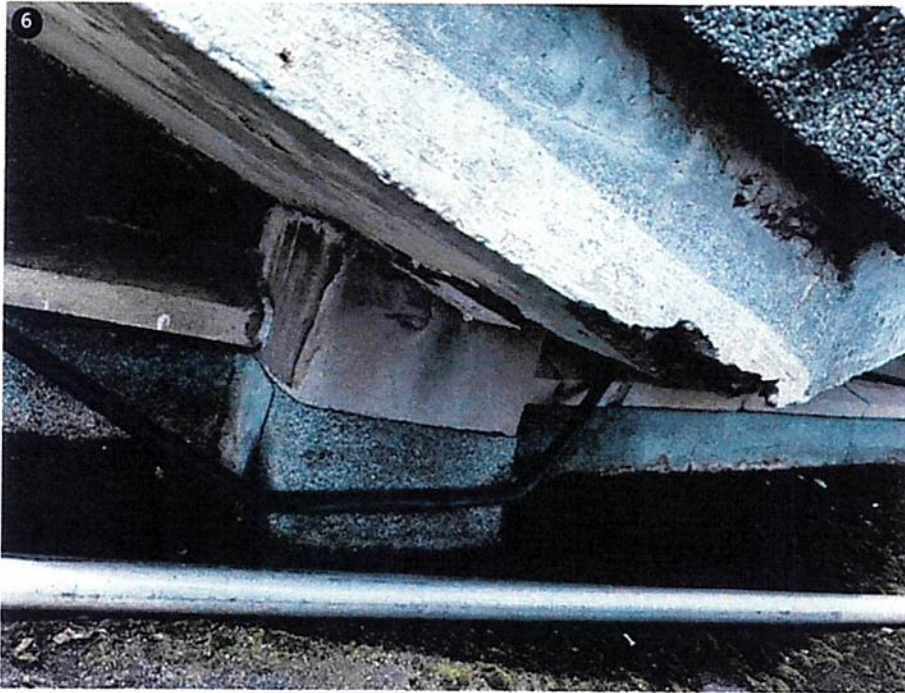
Existing outlets travel through the building
this should be taken external

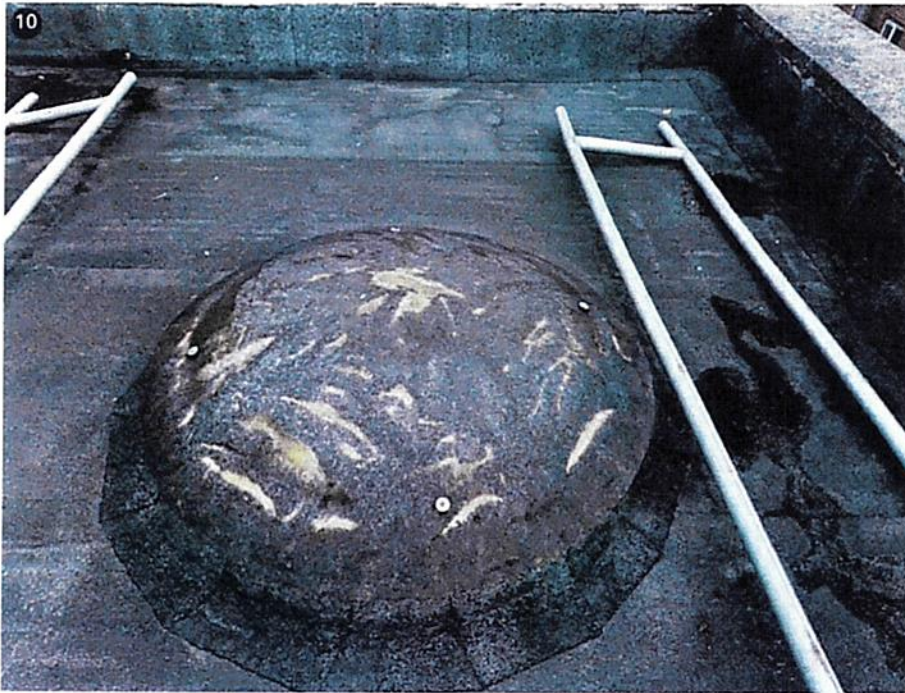
Poor condition of rooflights

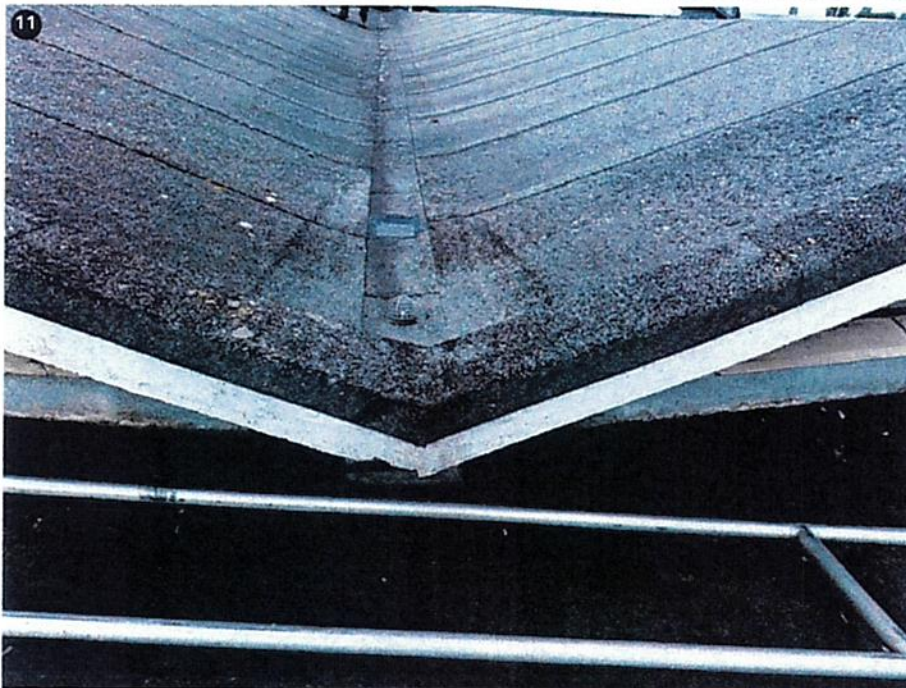
Further example of internal outlet detail where water is travelling through the building

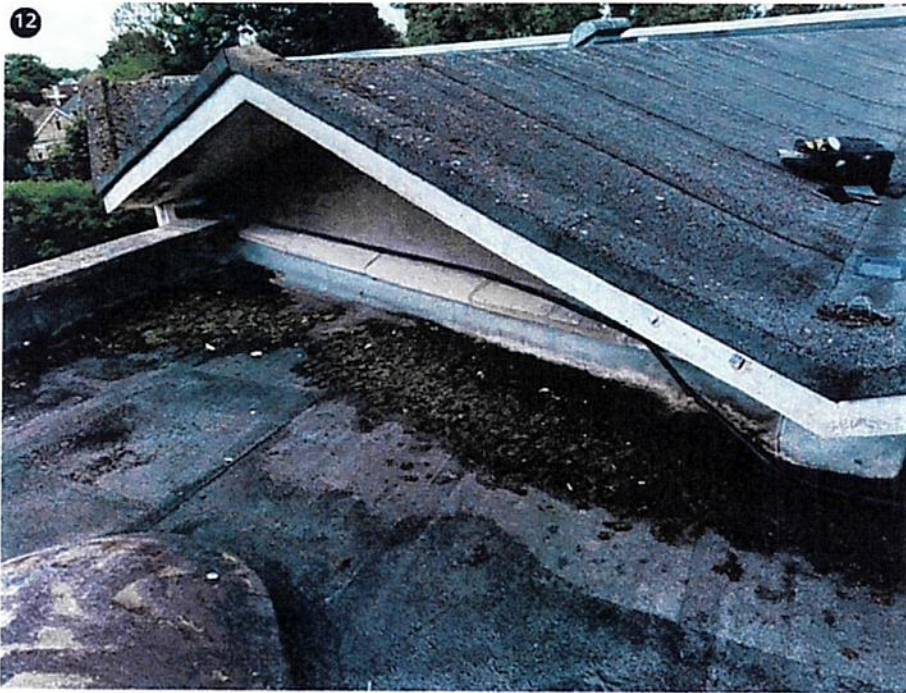
12

Area of moss growth indicating ponding water

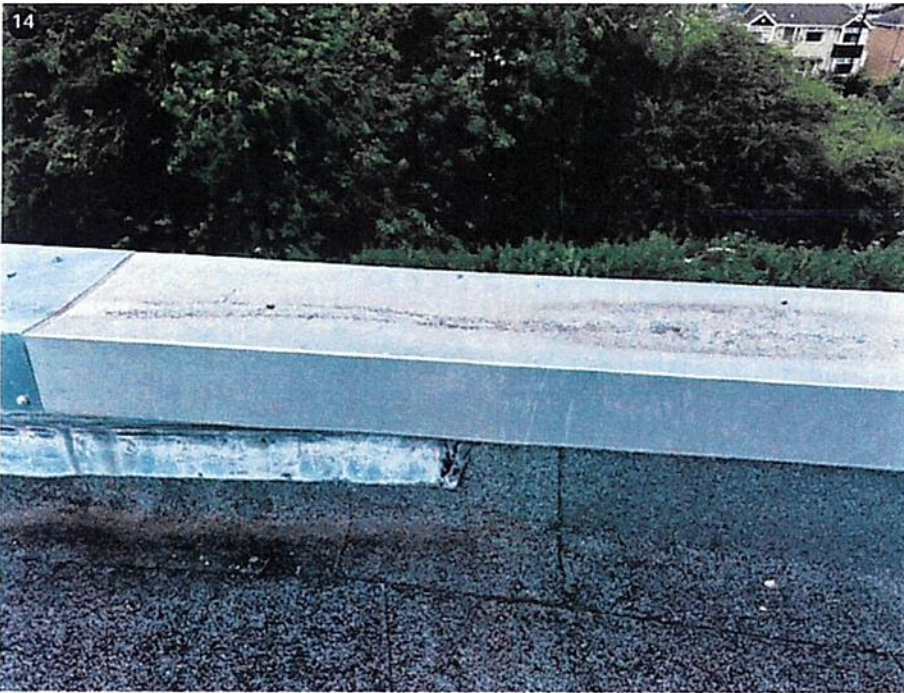
14

Previous repairs have been carried out

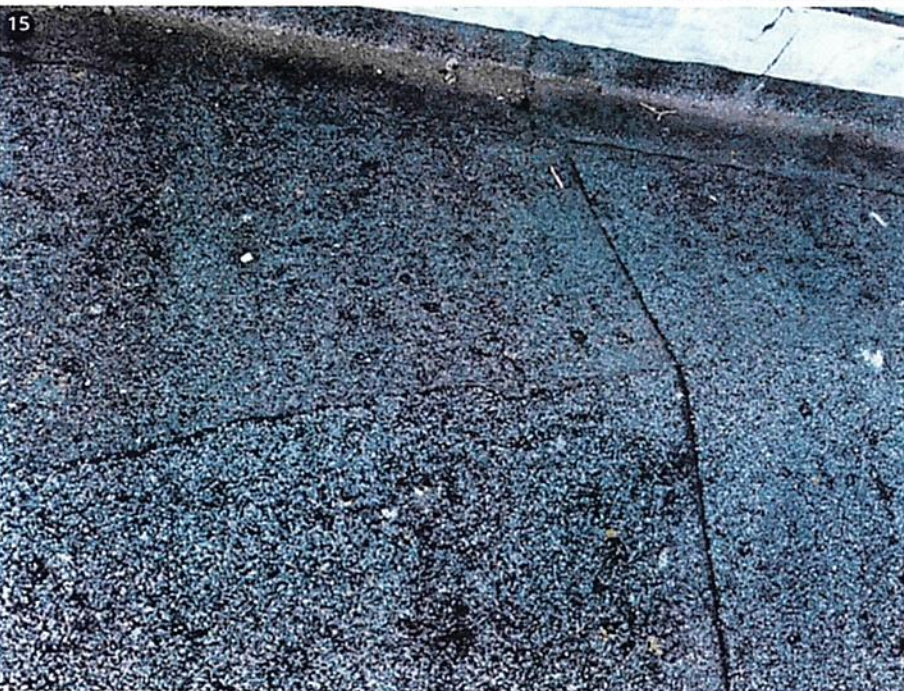
15

Visible splits starting to show

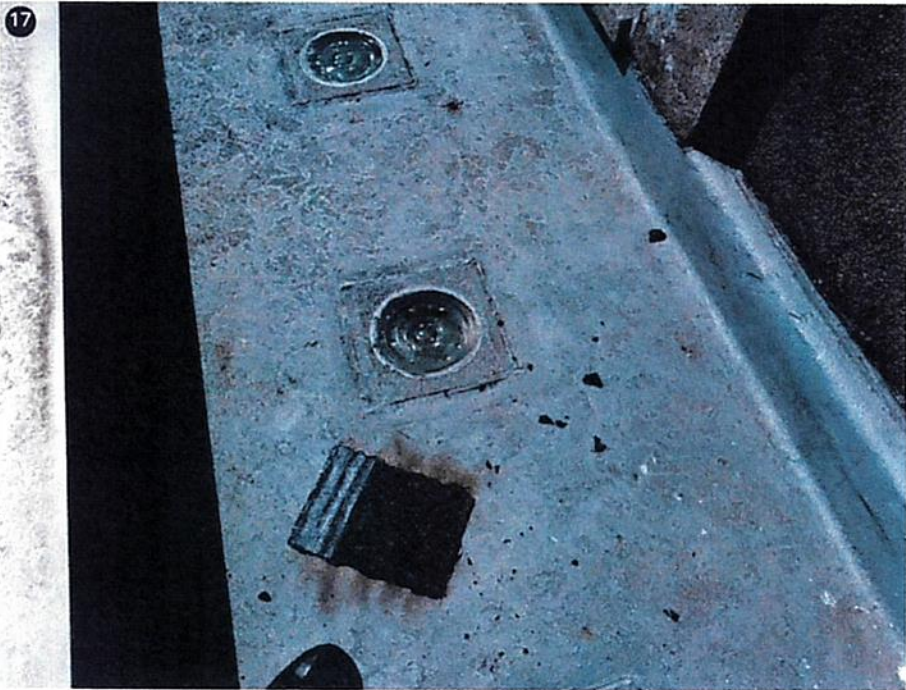
17

Core sample revealed asphalt over concrete deck

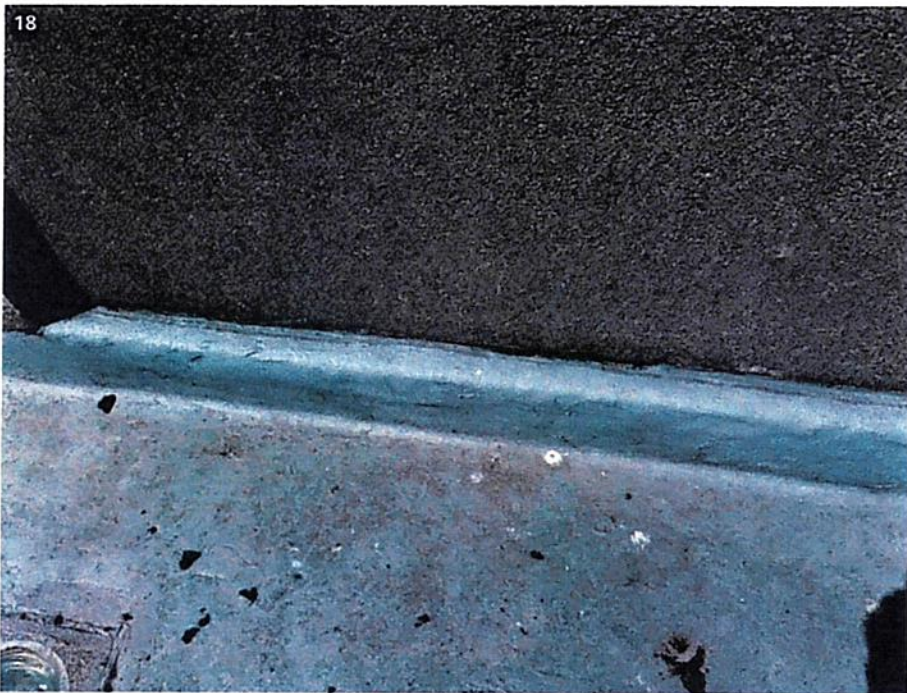
18

Poor upstand detail

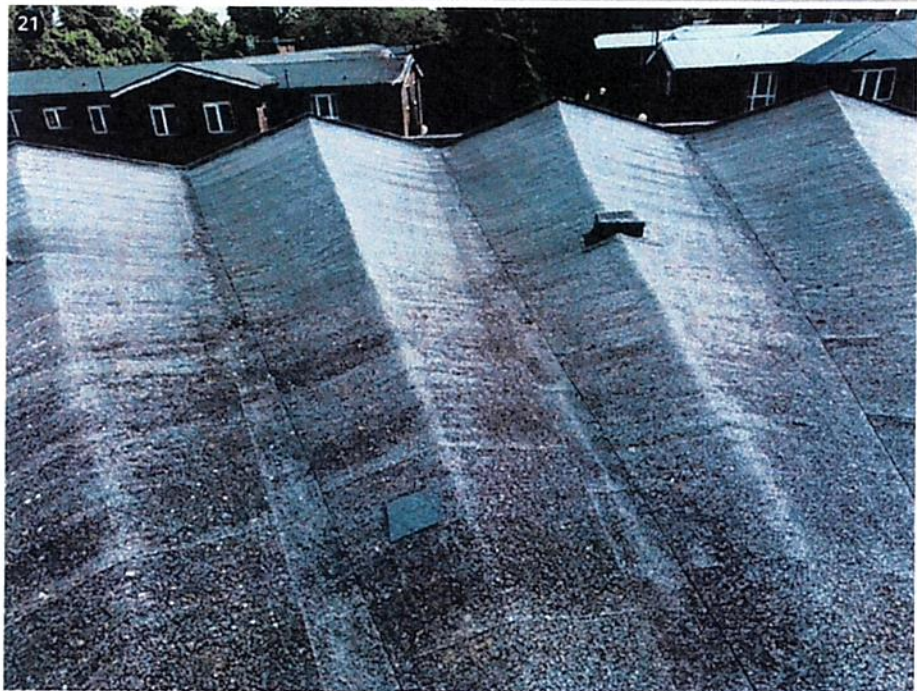
21

Existing membrane showing signs of mineral loss and deterioration

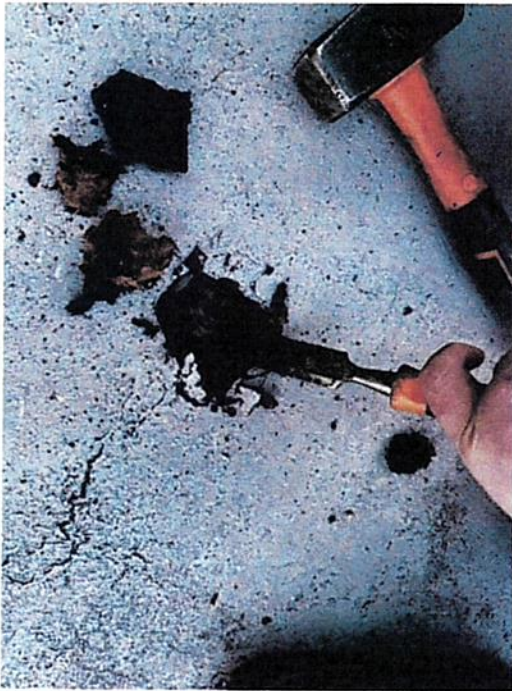
24

Core sample to lower area R3 showed fibre board over concrete

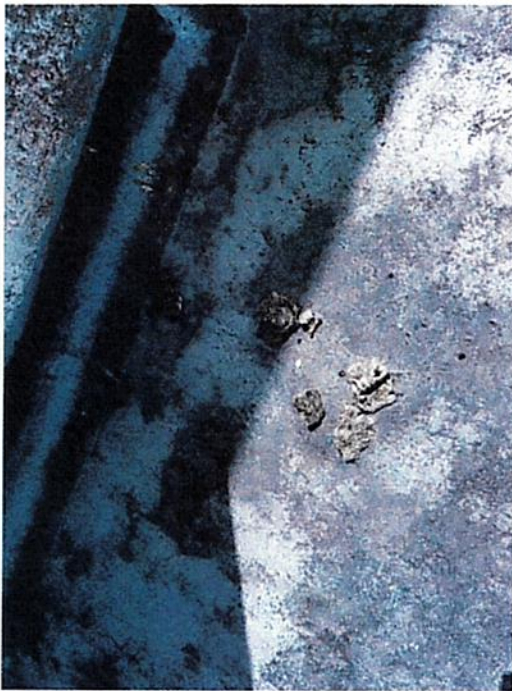
28

Evidence of spalling

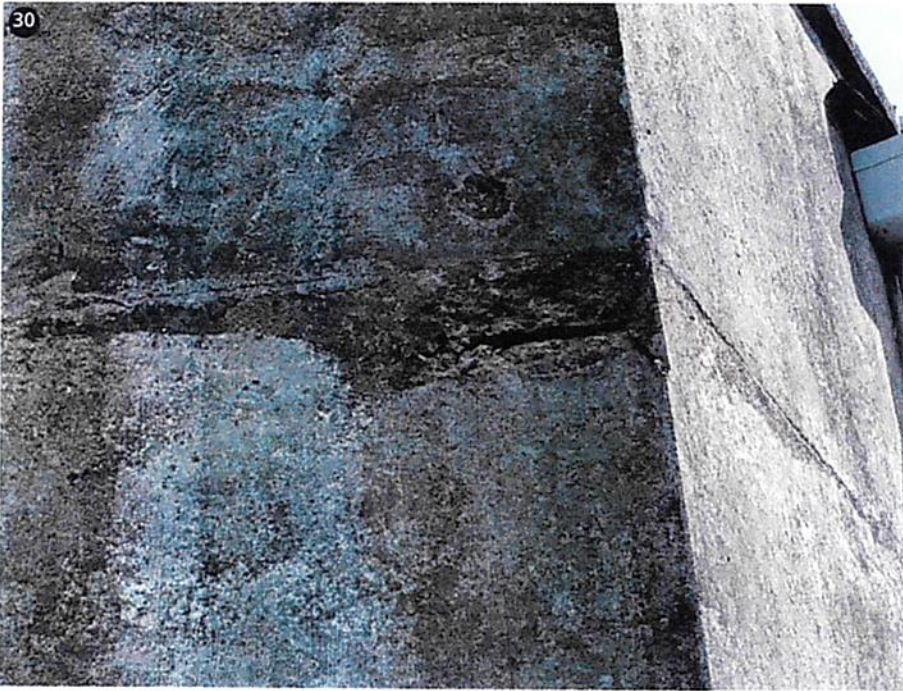
30

Spalling to vertical section

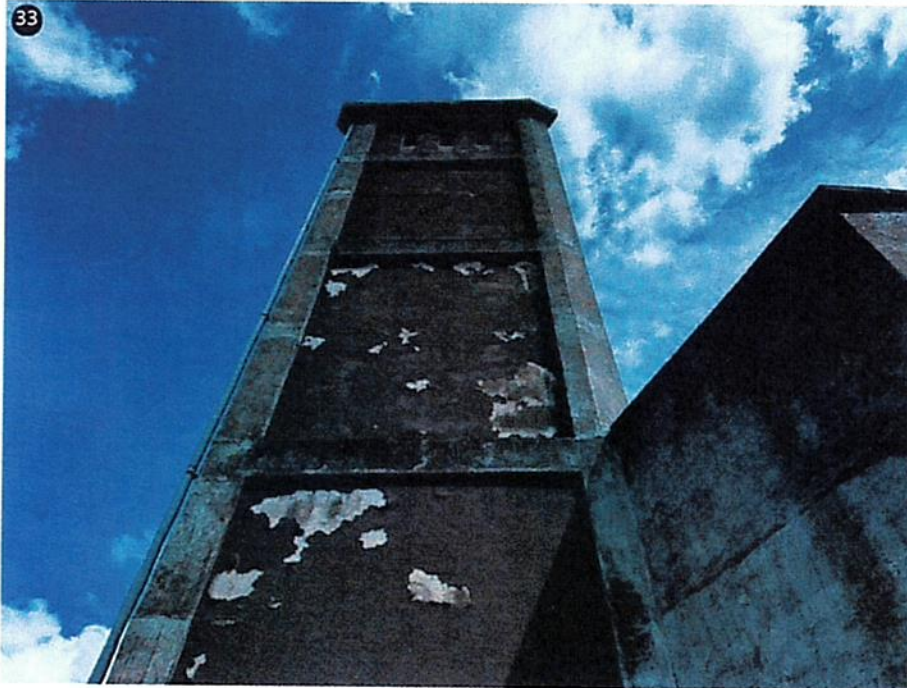
Existing condition of tower - This could be cladded to encapsulate or treated

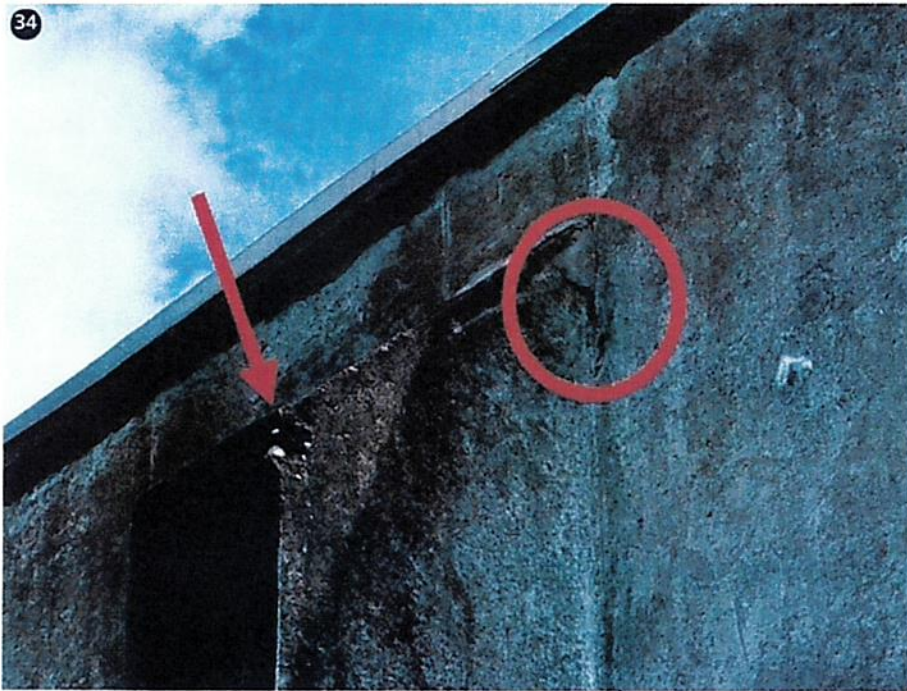
34

Further evidence of spalling

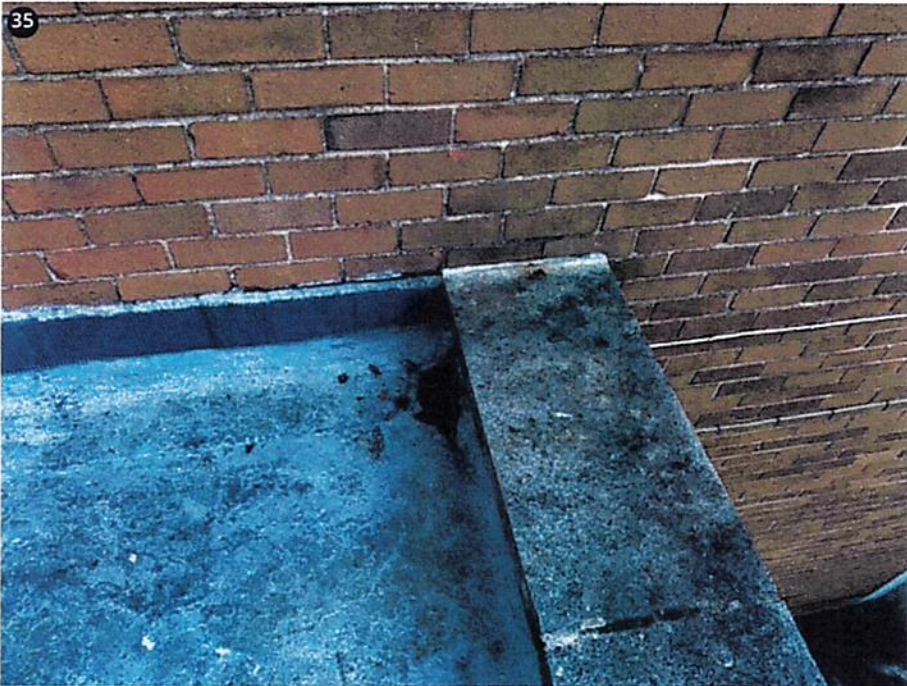
35

Poor detailing noted to upstands

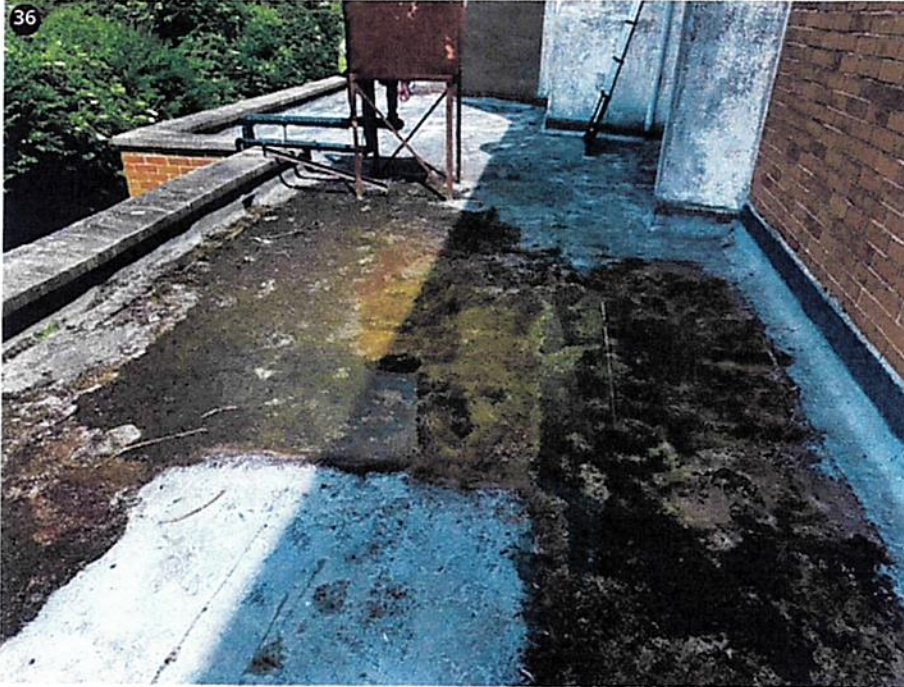
Overview showing ponding

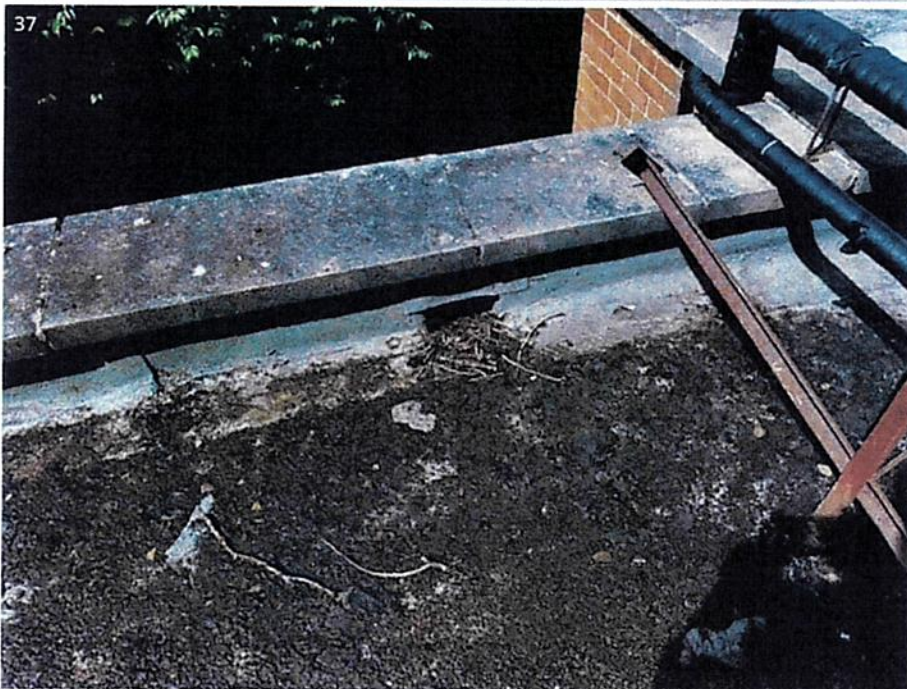
Blockage

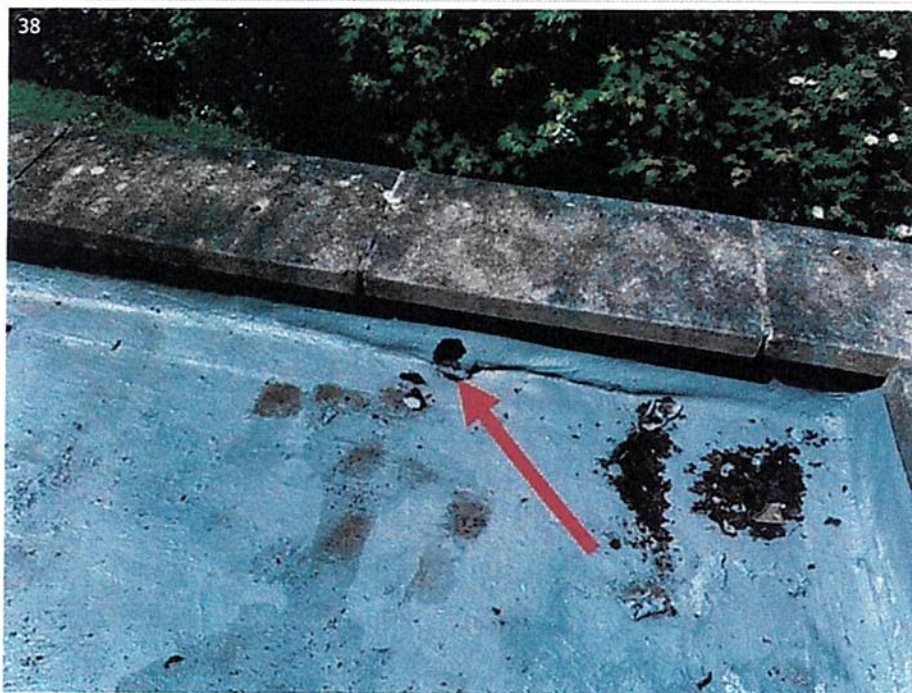
38

Failed section to parapet

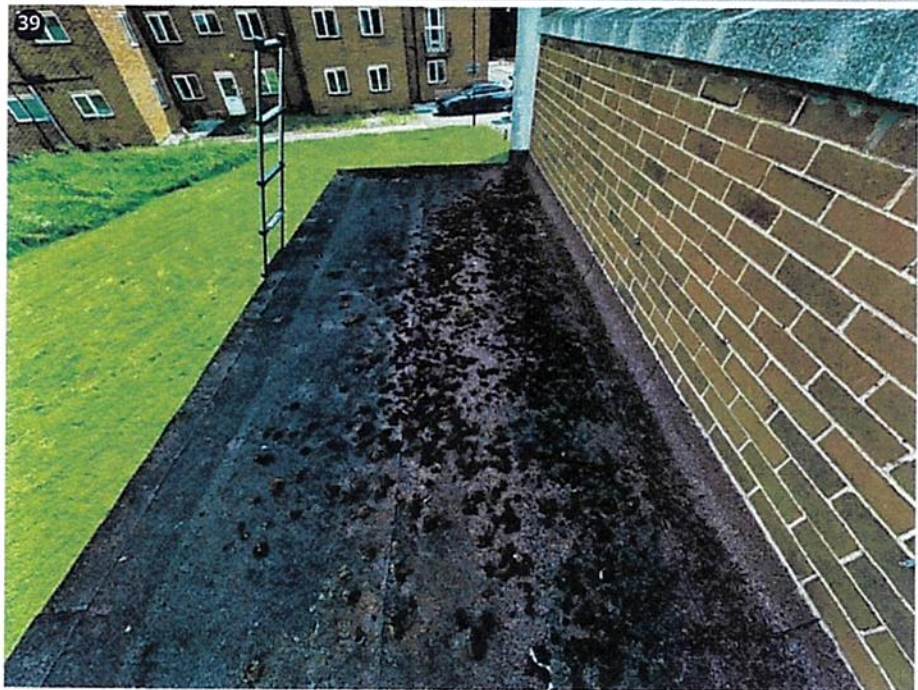
39

Lower sections are in reasonable condition

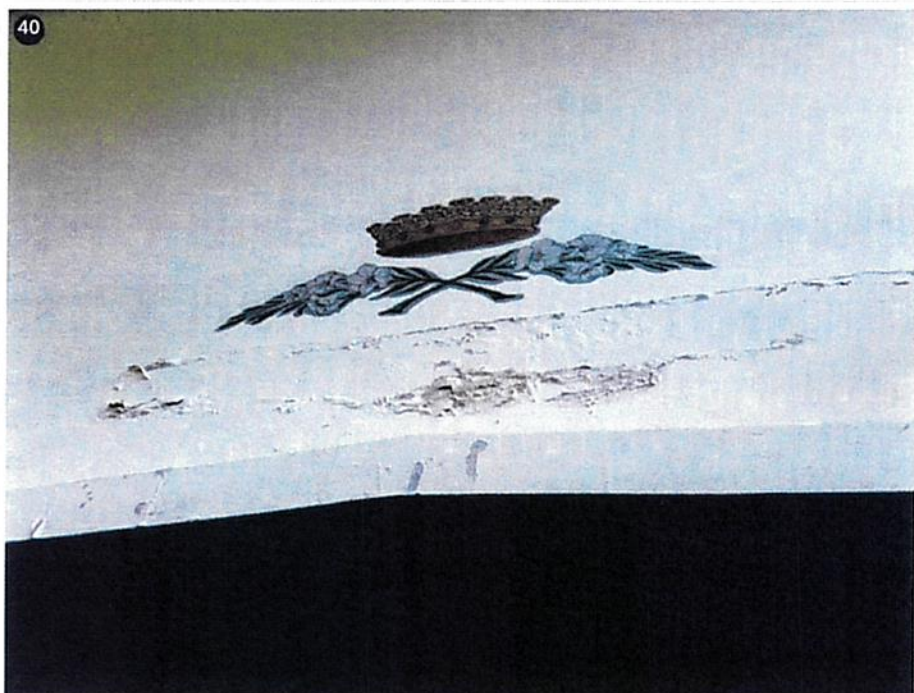
40

Internal damage

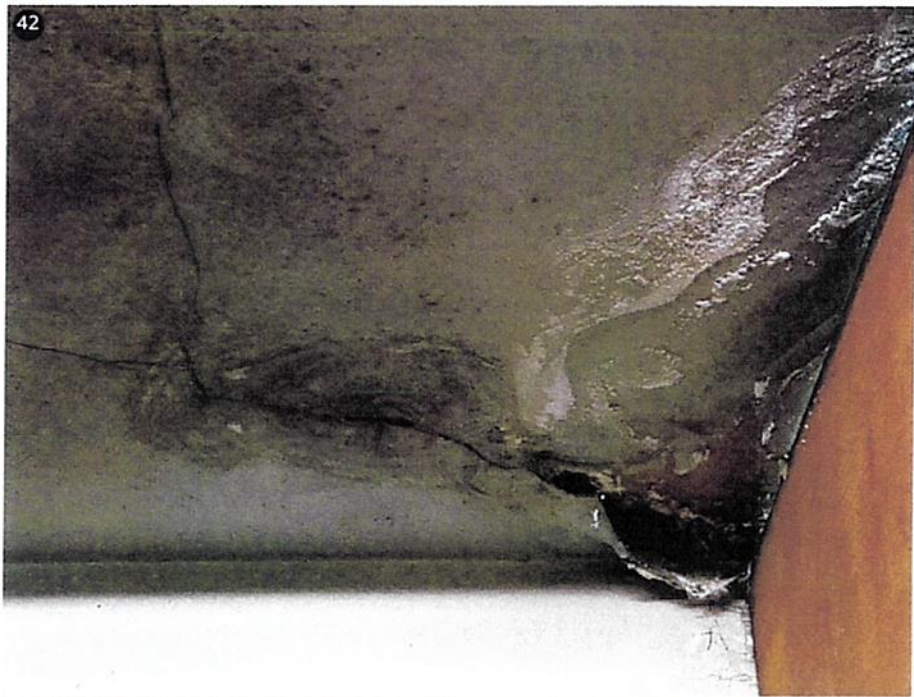
42

Further water ingress damage

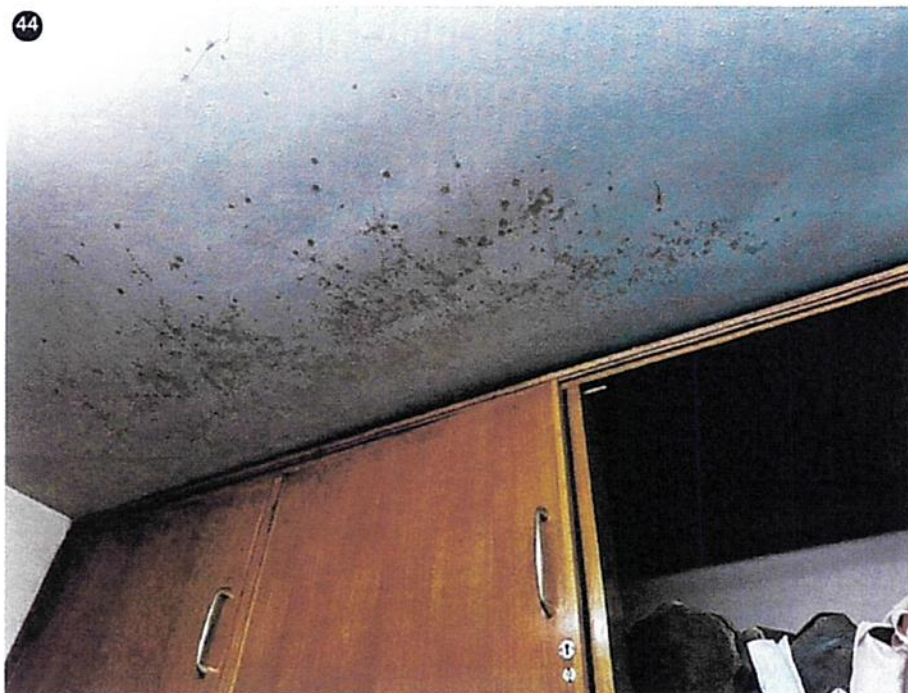
44

Water damage
